State of California — The Resources Agency  
DEPARTMENT OF PARKS AND RECREATION  
**PRIMARY RECORD**

\*Resource Name or #: 545 N. Howard Ave.

\*P11. Report Citation: Covina Town  
Center Historic Resource Survey  
prepared for City of Covina by Historic  
Preservation Partners (2006-7)

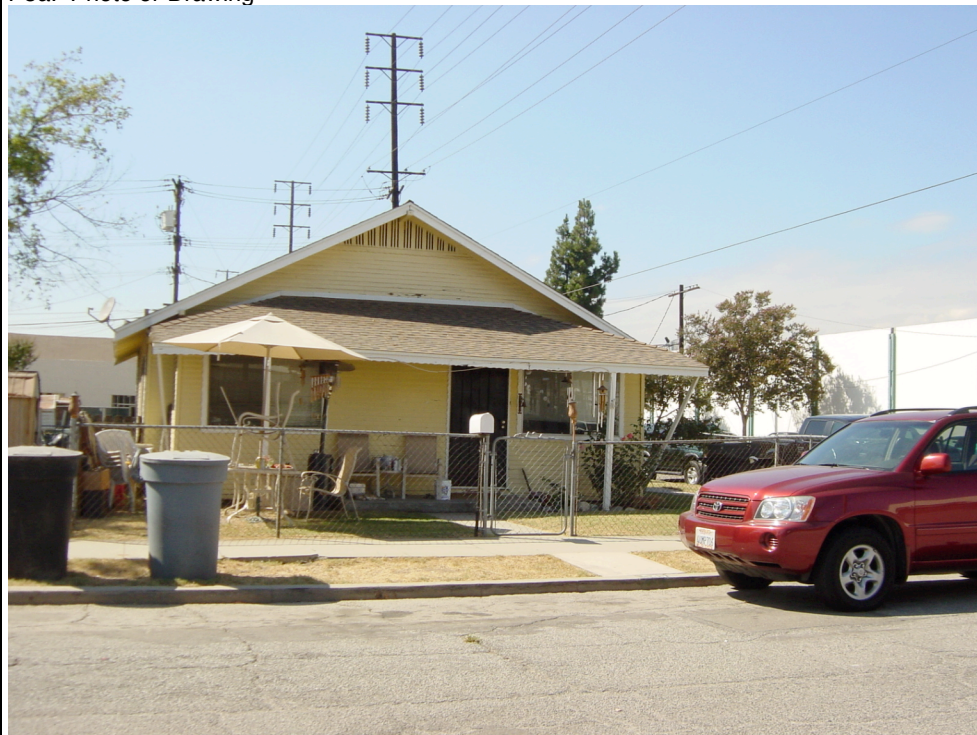
P5a. Photo or Drawing

The house located at 545 N. Howard Ave. is a Craftsman bungalow, constructed in 1925, according to the Los Angeles County Assessor. The clapboard house has a square plan and front facing gable roof with full-width projecting front porch with shed roof (possible alteration), and decorative stickwork at the gable peak. The house's character-defining features are the stickwork, clapboard exterior, and exposed eaves. The house sits close to the street in a small residential and industrial area north of the downtown. The property is listed with the County of Los Angeles as being a multi-family residential property with two improvements: 1 – 996 square foot 2 bedroom, 1 bath residence constructed in 1925, and 2 – 480 square foot 1 bedroom, 1 bath residence constructed in 1934. The front house (unit) appears to have had some exterior alteration, including the porch, security door, aluminum windows, and porch support posts. The property seems to be in fair to good condition. An additional element of the property is the buildings behind 545 N. Howard that are thought to be part of the property (see continuation sheet).

P5b. Description of Photo:  
View W (10/2/06)

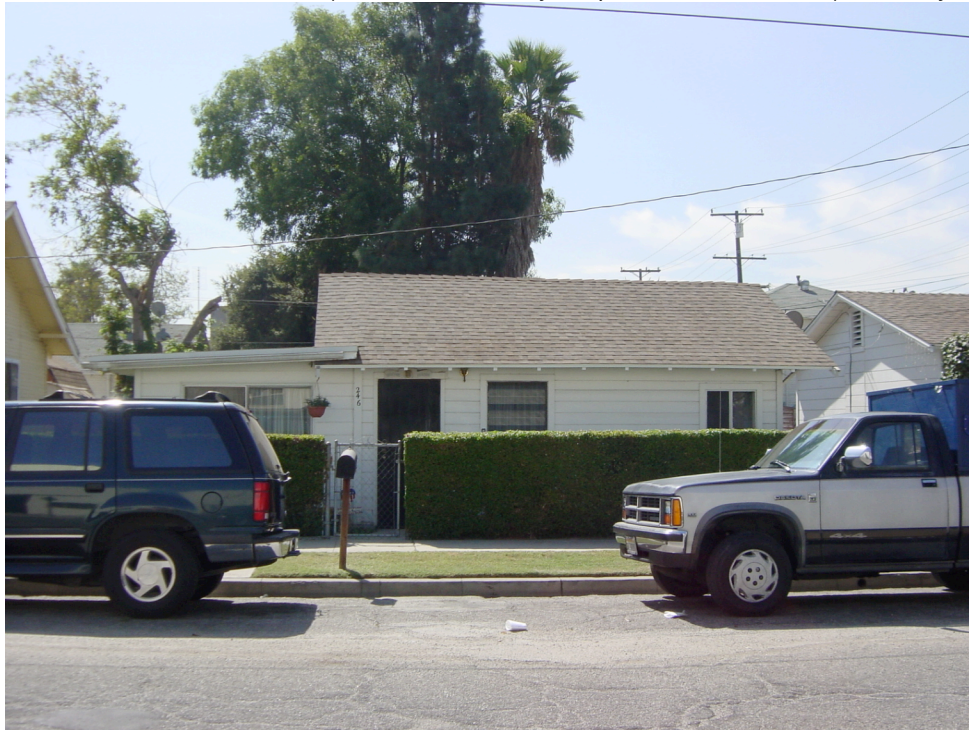
2 units behind 545 N. Howard (not confirmed if they are part of 545 N. Howard). The City has no records for these units.
